DDASaccident418

DDAS Accident Report

Report date: 19/05/2006	Accident number: 418
Accident time: 15:30	Accident Date: 08/10/2003
Where it occurred: Malvil Village, Pallai region, Kilinochi District	Country: Sri Lanka
Primary cause: Inadequate survey (?)	Secondary cause: Inadequate equipment (?)
Class: Missed-mine accident	Date of main report: 10/10/2003
ID original source: TG/RS	Name of source: LA
Organisation: Name removed	
Mine/device: M15 AT blast	Ground condition: hard route (verge)
Date record created: 21/07/2005	Date last modified: 21/07/2005
No of victims: 3	No of documents: 2

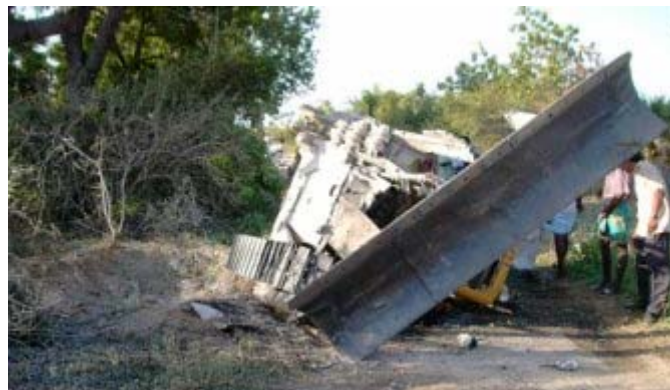
"A bulldozer and crew contracted by the GA and managed by the AGA was working in Malvil on the day of the incident. [Victim No.1], Bulldozer driver, [Victim No.2], Driver's Assistant and [Victim No.3], AGA appointed foreman were tasked with levelling the SLA bunds and clearing excess vegetation around the village. Immediately prior to the incident the bulldozer was on the dirt road running through the village and attempting to turn around. As the bulldozer moved off the road in its attempt to turn, an explosion occurred under the right hand track, tipping the bulldozer over and throwing the three contractors away from the site.

[The picture above shows the bulldozer after the accident.]

“It is apparent that the direct pressure from the bulldozer activated a metallic anti-tank mine, while driving off the edge of a well used road. The mine appears to have been an M-15 anti-tank mine laid by the SLA as part of their defences in Malvil Village.

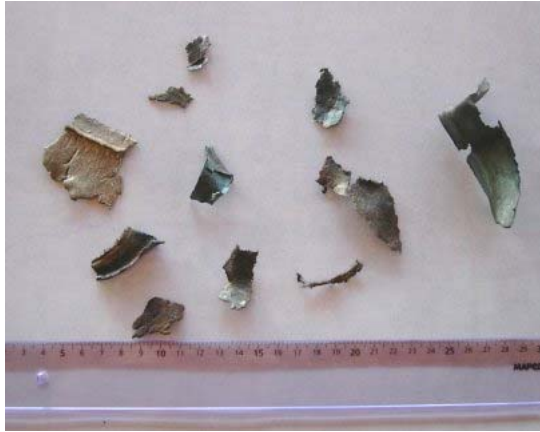
“Thin metal fragments were found in the crater left by the explosion. These fragments are consistent with that of an M-15 anti tank mine commonly used by the SLA.

[The picture above shows the recovered fragments.]

“Risk assessments conducted prior to mine clearance activities should include a consideration of anti-tank mines in the task area.

“Additionally, an electronic means of efficiently locating anti-tank mines should be considered to enhance the capability of [Demining group] deminers in the Vanni.”
